Pre-Demolition Inspection for Asbestos-Containing Building Materials

December 16, 2015

Project Site: Vacant Buildings
817 Brown Trail and
820 Uptown Boulevard
Bedford, Texas 76022

LCA Project No.: 151209

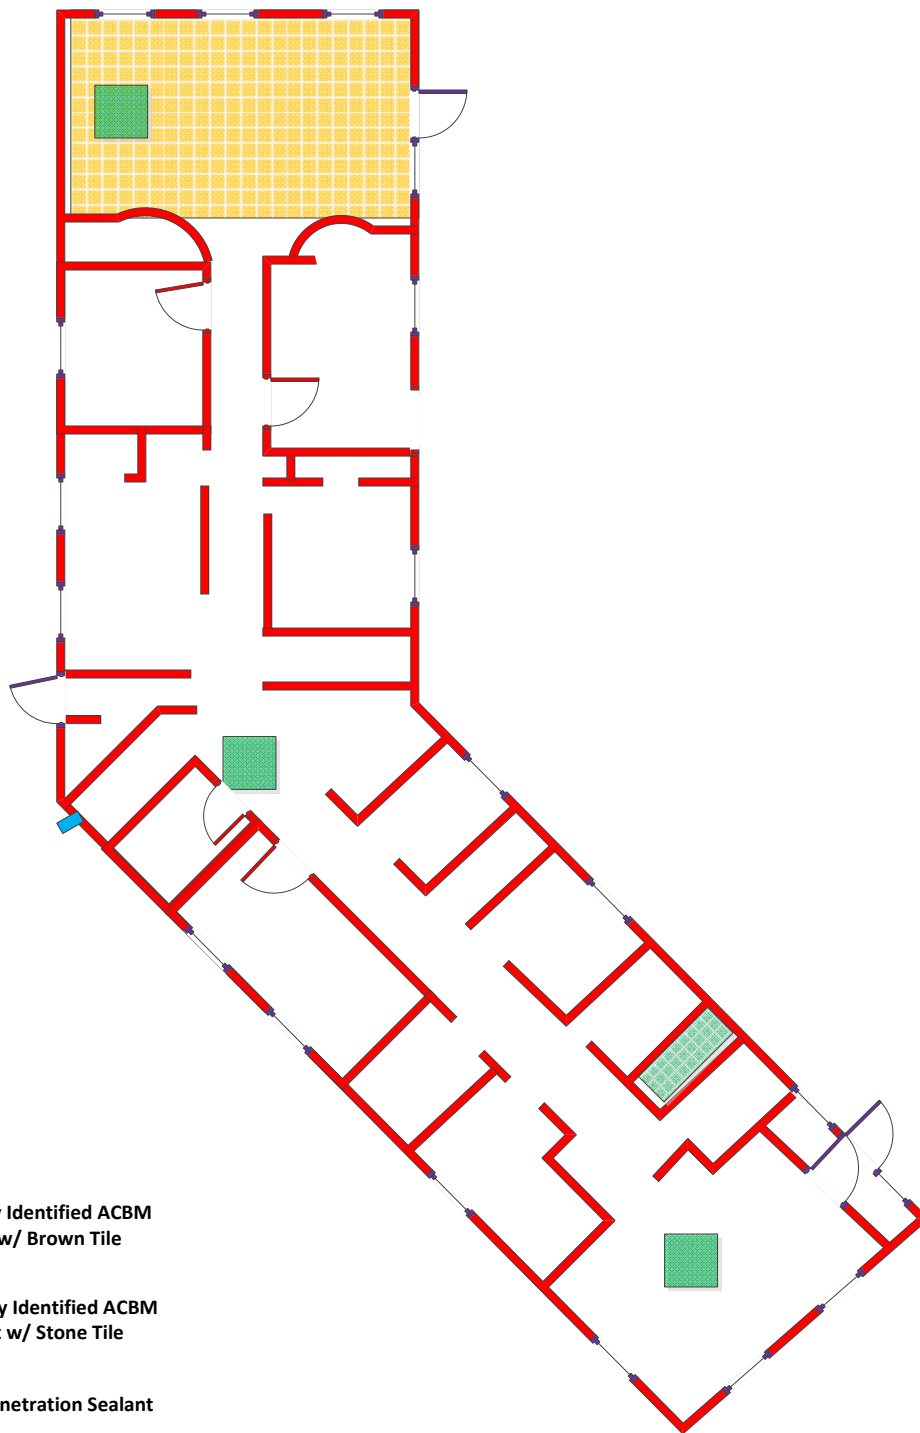
Figure 3

Identified ACBM	Asbestos Content	Approximate Location	Approximate Impacted Quantity
Joint compound/texture associated with drywall system ¹	3% Chrysotile	Throughout interior	12,000 ft ²
Grout associated with brown ceramic tile ¹	2% Chrysotile	Bathroom	120 ft ²
Window caulk ¹	3% Chrysotile	25 windows	400 linear feet
Grout associated with stone tile ¹	2% Chrysotile	North entry foyer	550 ft ²
Roof flashing ¹	5% Chrysotile	Perimeter of roof	685 ft ²
Cove base mastic (black)	5% Chrysotile	Throughout interior	1,000 linear feet
Exterior door caulk (white)	5% Chrysotile	Three exterior doors	70 linear feet
Roof penetration sealant	5% Chrysotile	Roof	300 ft ²
Vertical expansion joint	5% Chrysotile	West side corner	12 linear feet

NOTE: Previously identified ACBM roof flashing is located around the perimeter of the roof

In accordance with the EPA NESHAP and TDSHS TAHPR regulations, these materials must be removed prior to any activity that might be expected to disturb them. The removal of these materials must be performed by a TDSHS-licensed Asbestos Abatement Contractor following procedures designed and monitored by a TDSHS-licensed Asbestos Consultant.

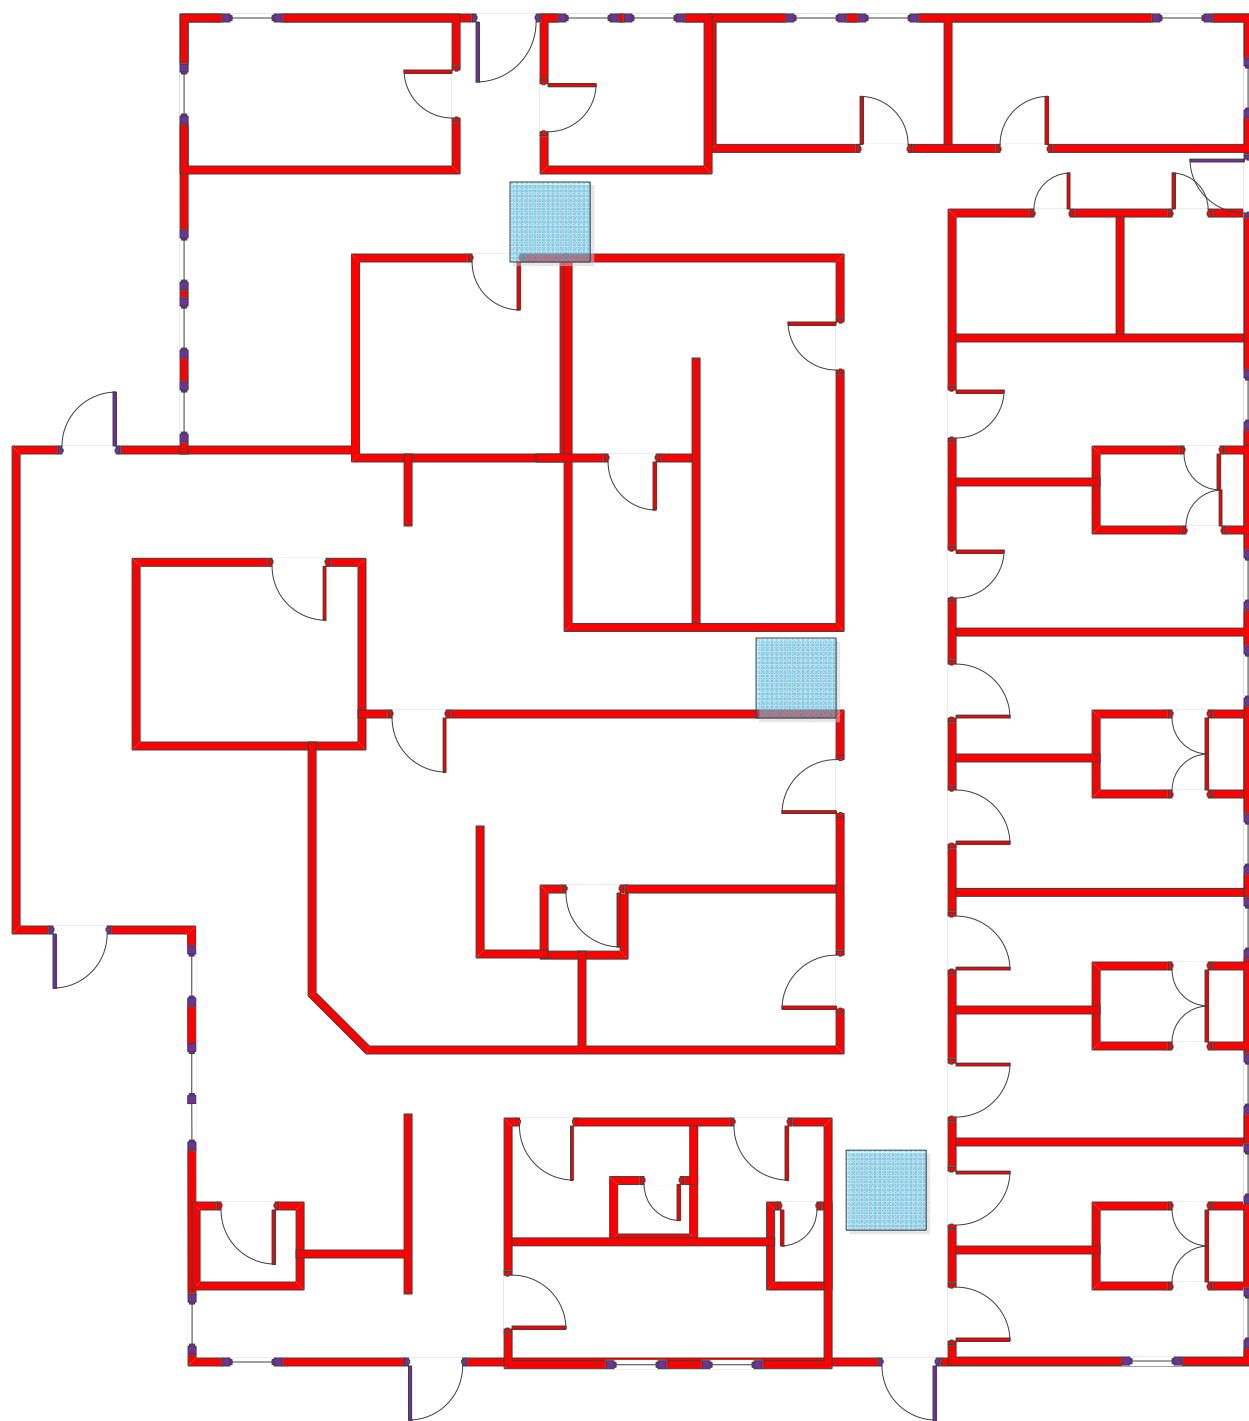
Figure 4
Asbestos Location Plan

Identified ACBM	Asbestos Content	Approximate Location	Approximate Impacted Quantity
Wall texture associated with drywall system ²	1.5% Chrysotile	Throughout interior	10,000 ft ²
Exterior door and window caulk (white)	5% Chrysotile	6 doors and 27 windows	510 linear feet
HVAC sealant (black painted white)	5% Chrysotile	Roof top units	100 ft ²
HVAC sealant (grey)	5% Chrysotile	Roof top units	75 ft ²
