RFP# 24-0301 - General Contractor Services for X-Ray Room Upgrades

ADDENDUM #1

LIMITED PRE-RENOVATION ASBESTOS INSPECTION

JPS – Bardin Road Clinic X-ray Room

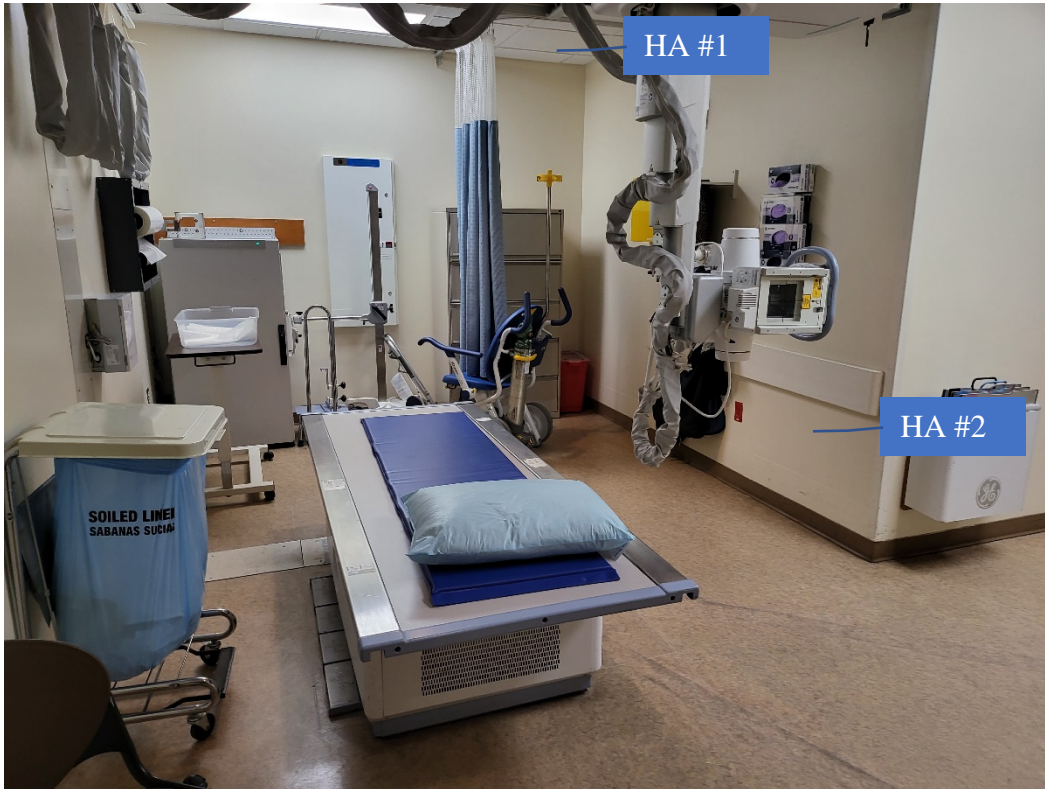
Photo 1: View of HA #1: non-ACBM 2' x 2' lay-in ceiling panels (rough), & HA #2: non-ACBM drywall wall system (eggshell).

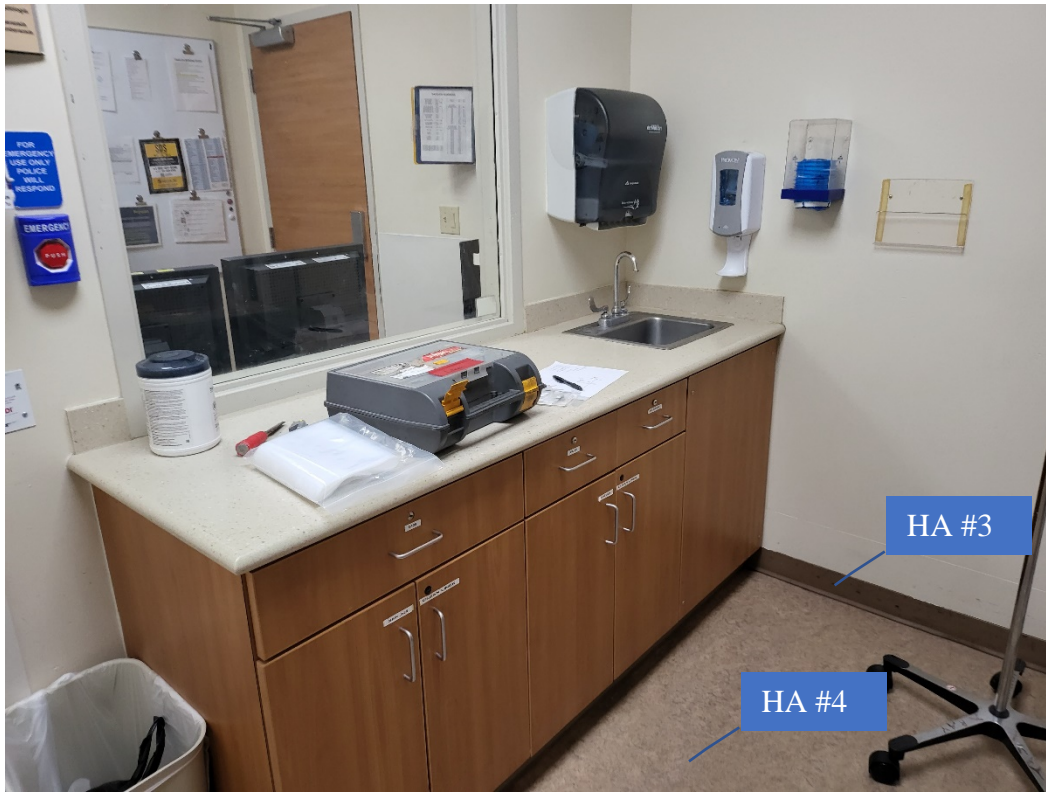
Photo 2: View of HA #3: non-ACBM 4" vinyl cove base (tan), & HA #4: non-ACBM sheet vinyl flooring.

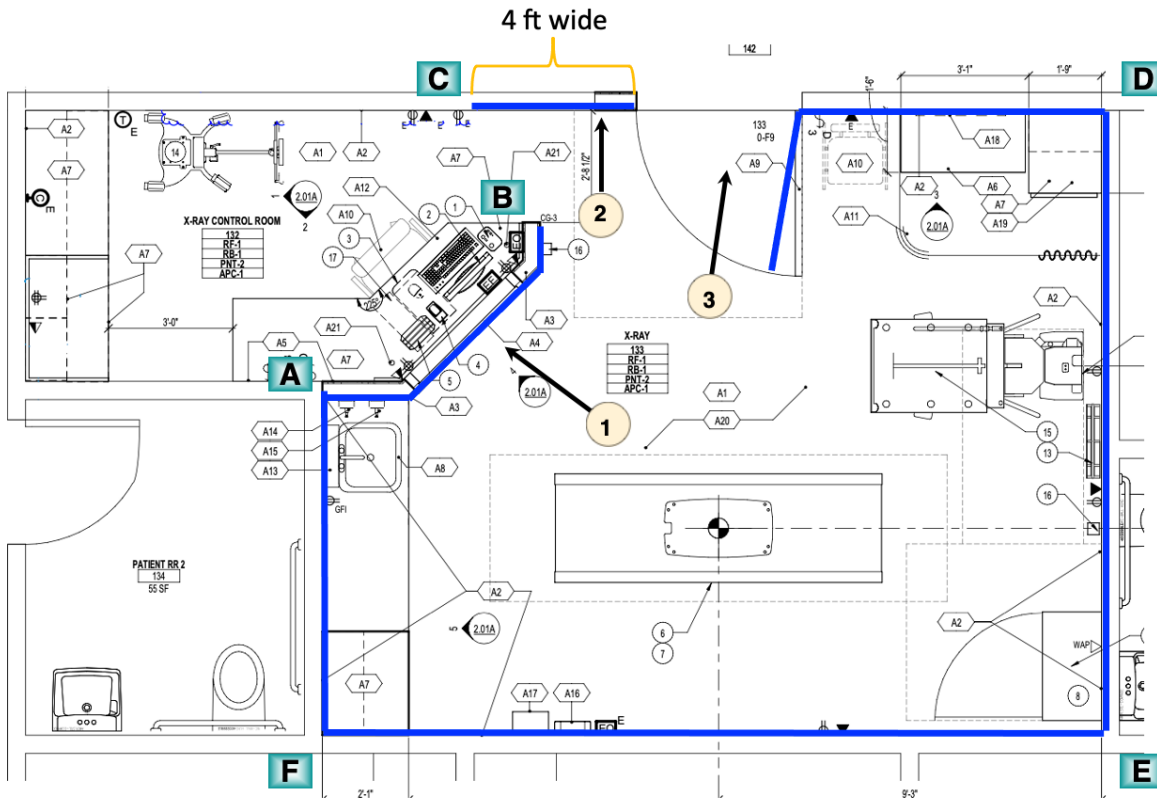
Table 2. Recommended Shielding: Radiography Room

Wall	Description	Restricted Area?	Occupancy	Recommended Shielding (Inches)	Comment
AB	Control booth	Yes	1	1/32nd in. Pb	See note 1
CD	Corridor & Entry	No	1/5	1/32nd in. Pb	See notes 2, 3
DE	Patient Restrooms	No	1/20	1/32nd in. Pb	-
EF	Doctor Office and Cast Room	No	1	1/32nd in. Pb	-
FA	Patient Restroom	No	1/20	1/32nd in. Pb	-
xx	Ceiling & Floor	No	1/2	None	See note 4

Note	Comment / Recommendation
1	The window and frame for the control room should contain at least the same amount of Pb equivalent shielding as the surrounding wall (1/32 nd inch). Regular plate glass should not be substituted.
2	At this location, due to the room geometry, a single sheet of leaded sheet rock should be installed.
3	The entry door and frame for the Radiography Room should contain the same amount of lead as the surrounding wall (1/32 nd in. Pb). <i>A regular wooden door should not be substituted.</i>
4	Supplemental shielding is not required in the floor or ceiling for this type of installation. The facility is a single level structure with no expected occupancy above or below.

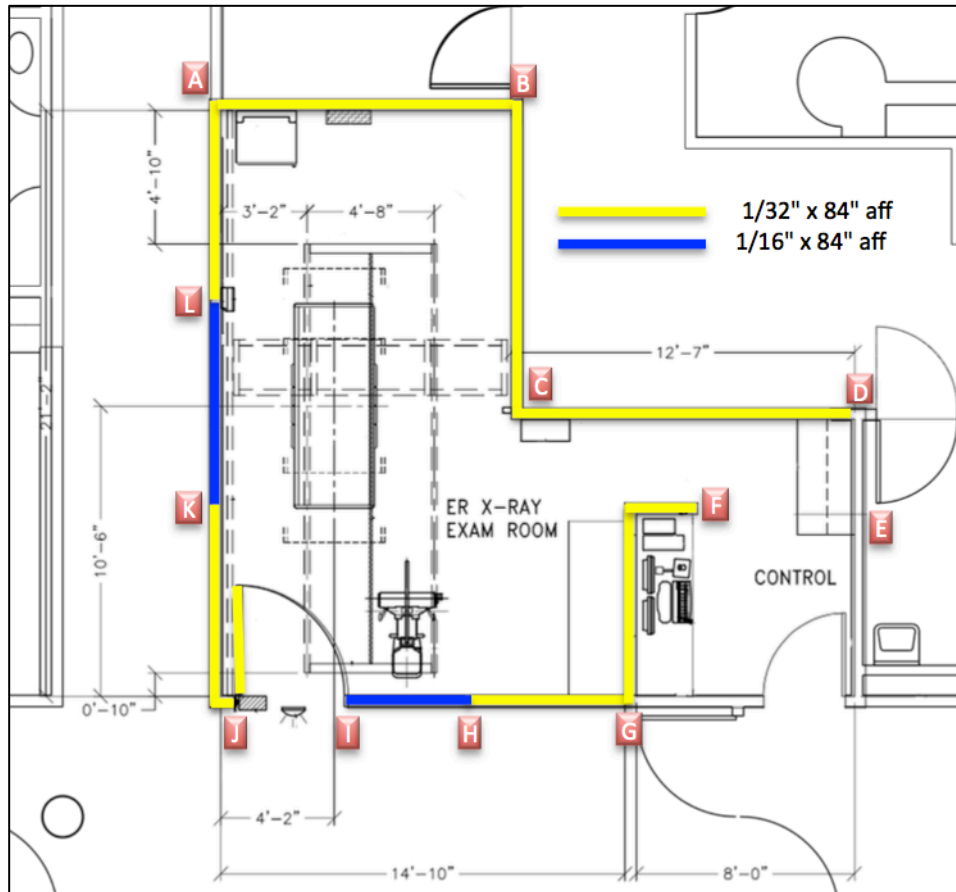
Figure 1. Shielding Design for the General Radiographic Suite, PCP-01.

Wall	Description	Restricted Area?	Recommended Lead	Comment
AB	Office	N	1/32"	
BC	Corridor	N	1/32"	
CD	Corridor	N	1/32"	
DE	Restroom	N	none	See note 1
FG	Control Room	Y	1/32"	See note 2
GH	Corridor	N	1/32"	
HI	Corridor (behind Chest Stand)	N	1/16"	See notes 3, 5
IJ	Corridor	N	1/32"	
JK	Corridor	N	1/32"	
KL	Corridor (behind table)	N	1/16"	See notes 4, 5
LA	Corridor	N	1/32"
